Case Study

Piper & Associates Pipe Slotting - Open Area

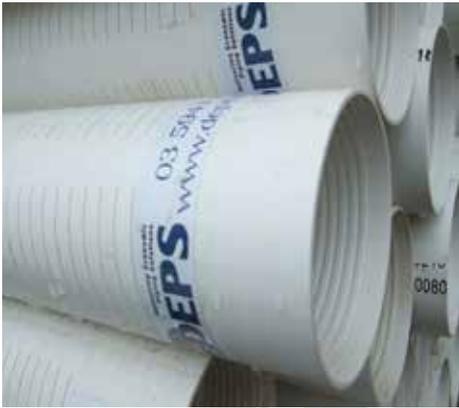
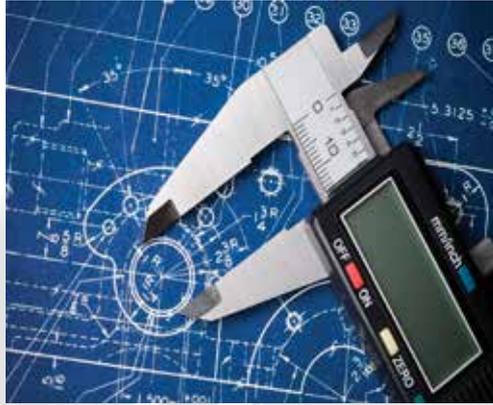
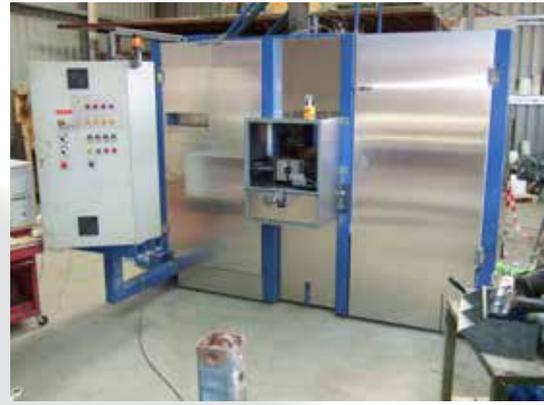
The solution was to use 150 cl12 UPVC threaded casing and screen pipe Australian AS1477 manufactureed pipe was used. Slot pattern machined was 1.2mm slots 4 rows 10mm spacing with 65 mm long slots. All components use standard pipe fittings that are of the shelf. The above specifications allowed 1- 5 L/S for the pump test required. To thread Casing and screen with a square form right hand thread.

Thread 150 cl12 casing and screen with our standard 4TPI square thread.

The Slotted pipe was machined on one of our Automated slotters to the required pattern specified.

150 cl12 pipe was used for the casing to allow a 6" pump to go into the bore, a 6" pump was necessary to meet the 5 L/s flow rate bore test.
